S-11
 Brittingham Farm
 Princess Anne vicinity
 private

Maryland Historical Trust State Historic Sites Inventory Form

Survey No. S-11

historic Brittingham Farm

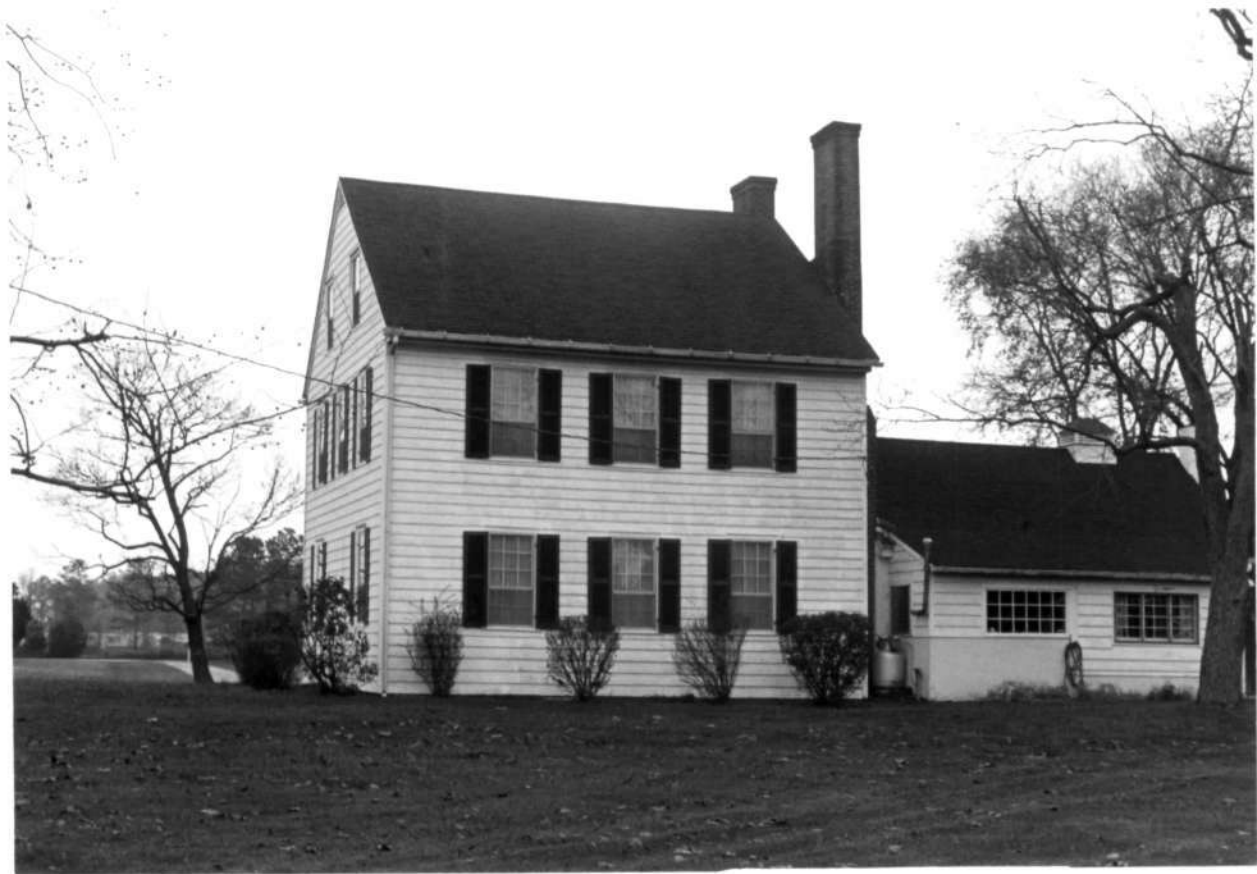
North Elevation

The north (rear) elevation is a symmetrical facade with three nine over six sash on the first and second floors. The cornice is detailed with the same drillwork bed molding that is found on the front of the house.

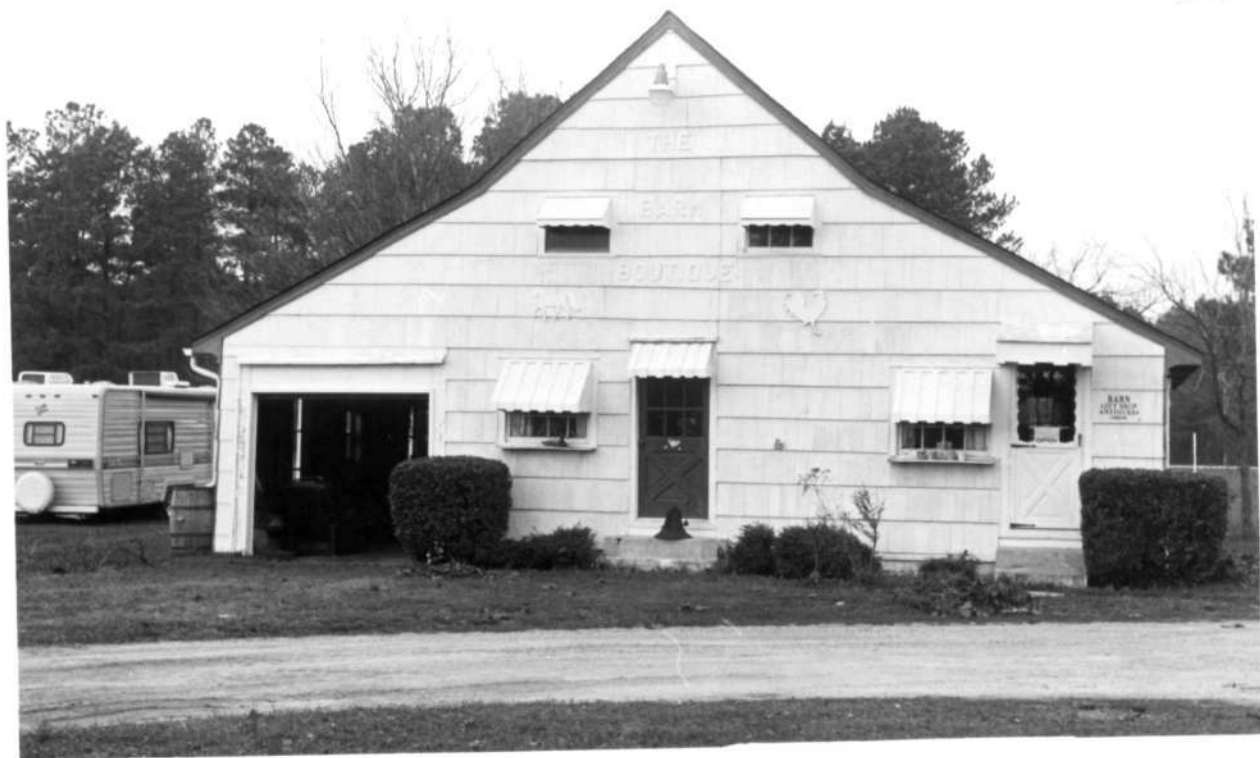
Granary

The only significant outbuilding is an early nineteenth-century mortise and tenon frame granary that has been converted into a gift shop. The center bi-level structure is flanked on each side by shed roofed wagon bays. Major alterations to the exterior and interior for conversion into a shop have compromised its original appearance.

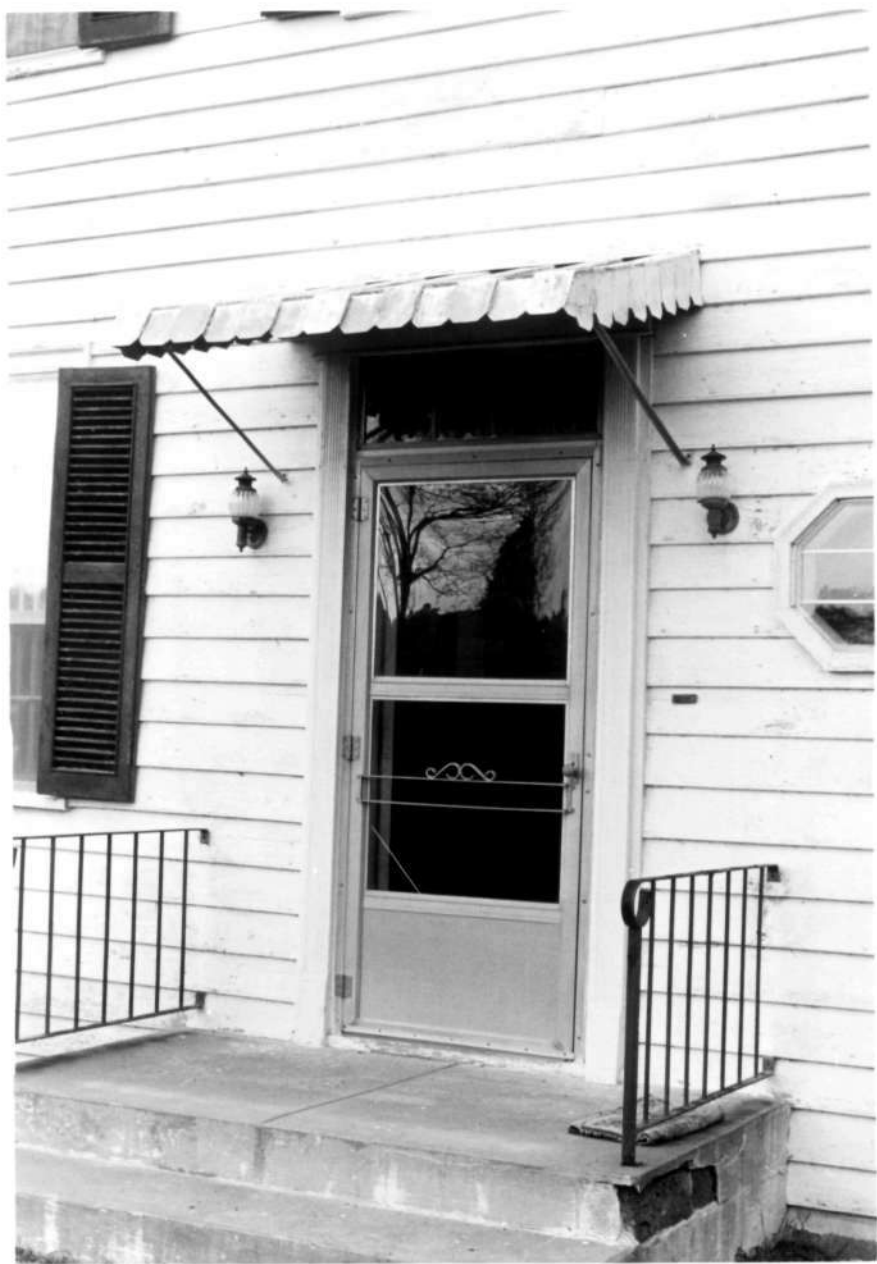
Brittingham Farm S-11
Princess Anne Vicinity, Somerset Co. Md.
Front Door
3/86, Paul Touart H Photographer
Neg/Md. Historical Trust

The south facade is a three-bay elevation with an entrance filling the east bay. The replacement six-panel door is topped by a four-light transom decorated with comma-shaped corner brackets. The doorway is framed by a Federal style surround with fluted pilasters and a molded entablature. The two adjacent bays are filled with nine over six sash windows that survive with early nineteenth century surrounds. Lighting the second floor are three evenly spaced nine over six sash windows. An enriched box cornice with a drillwork bed molding highlights the base of the roof.

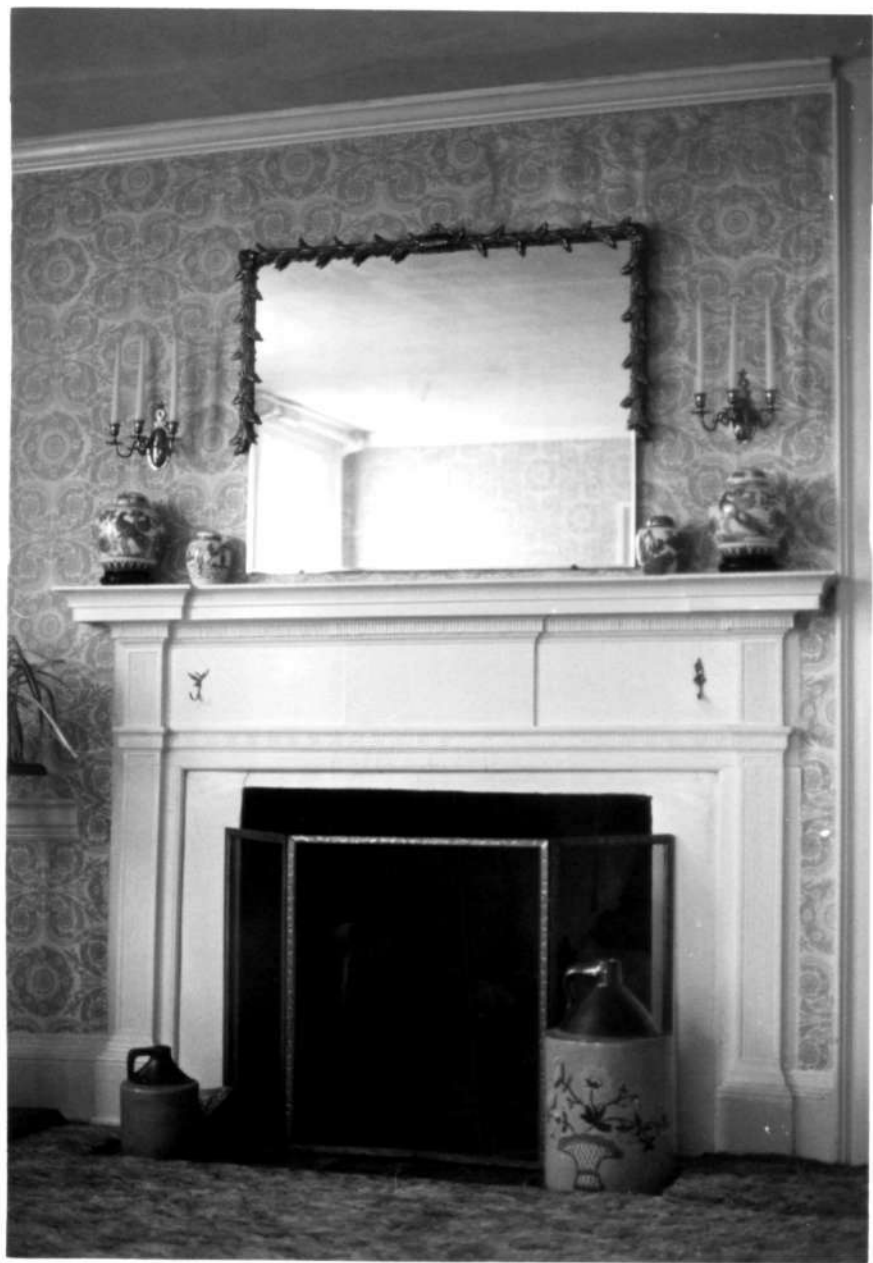
Parlor Mantel

The front room or parlor has the fanciest mantel in the house. Reeded pilasters with molded bases and capitals flank the firebox and support a five-part frieze. The bottom strip molding of the frieze carries a decorative row of gougework with four vertical line gouges that are interspersed with a star motif. The five-part frieze has two reeded end blocks and one plain center tablet. The cornice is broken, and it carries an enriched bed molding. The chair rail molding formerly fixed in this room has been cut out for the most part, but the period window and door surrounds were left intact.

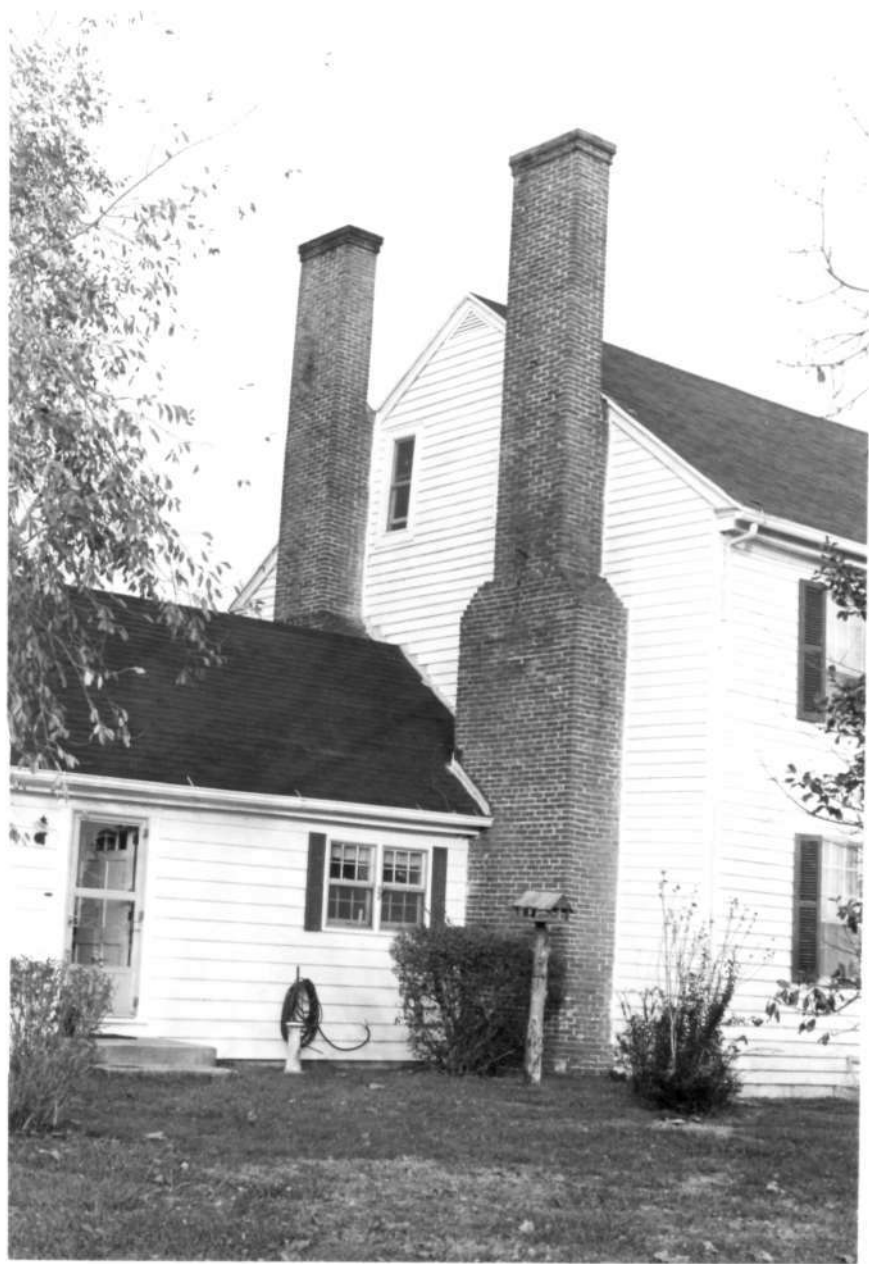
West Elevation

The west gable end is distinguished by a pair of exterior, seven-course common bond brick chimneys that have corbelled shoulders at the second floor height and corbelled caps. Attached to the west gable is a c. 1810 single-story kitchen that has been remodeled on the exterior. A few sections of beaded weatherboards remain on the west gable end.
